RESERVE FUND STUDY
REPORT

[REDACTED]
CONDOMINIUM CORPORATION

CONDOMINIUM PLAN No. [REDACTED]

April 2017

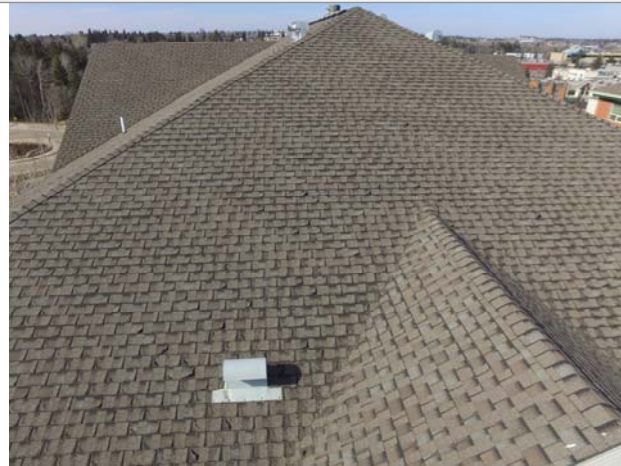
- Shingle roofing is showing signs of wear and deterioration.
- Flat roofing (asphalt and gravel) at side entrance is also nearing its expected life.

Shingle deterioration evident

- Shingle roofing should be scheduled for replacement within the next 3 years. Small flat roof should be replaced at the same time.

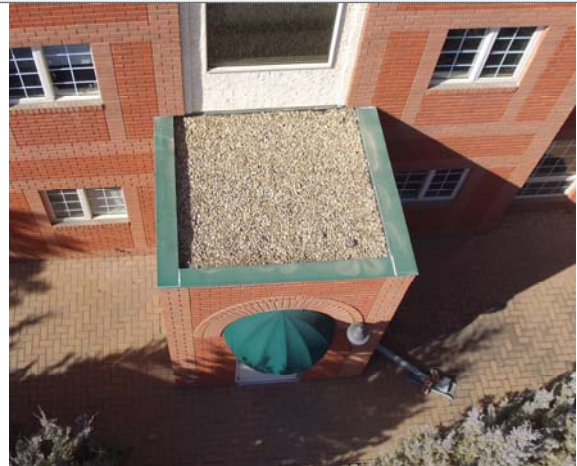
Flat roof

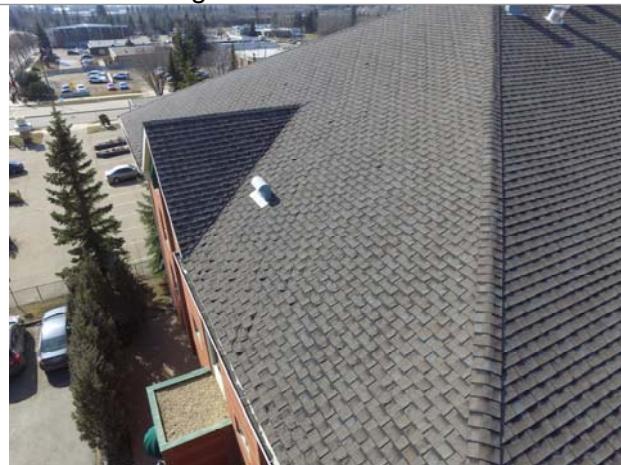
Shingle deterioration evident

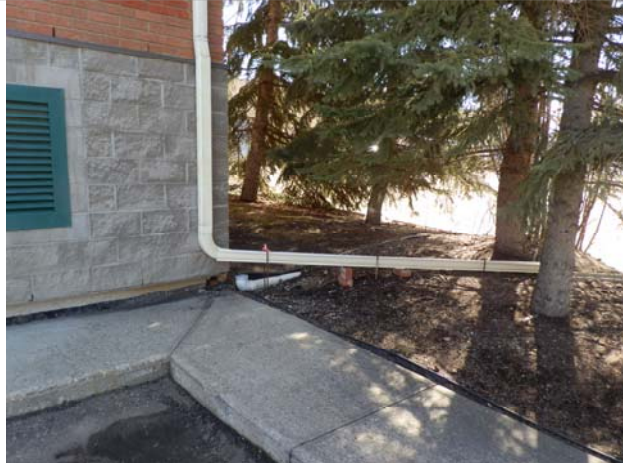
- Eavestroughs are securely fastened to fascia with ferrules (nails).
- Eavestroughs appear to have minor organic debris. This debris may cause downspouts to plug and back up.
- Downspouts terminate onto landscaping. Internal drainage system is no longer being used. A few downspouts terminate close to the foundation walls.

Downspout terminating away from foundation

- Ensure downspouts terminate away from foundations.

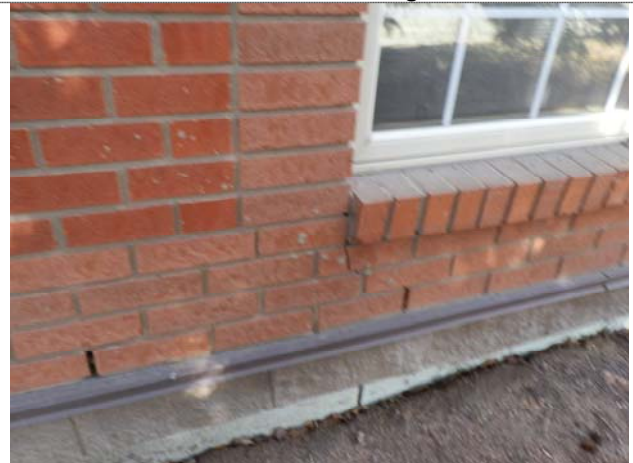
- Building is clad with mostly brick. Stucco is installed at balconies and stairwells.
- Brick is in good condition and should last the life of the building with minimal maintenance and repair.
- There are a few areas where the mortar is damaged.
- Stucco is in good condition. It should last the life of the building. Minor repair and maintenance will be required.

Damaged brick

– Money is allocated to repair brick and stucco as needed.

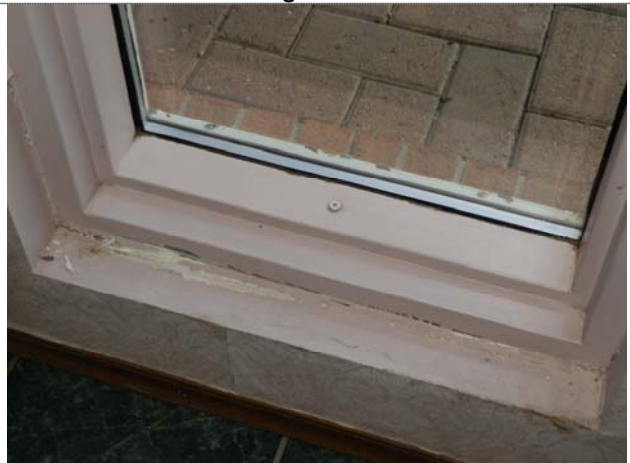
- Windows are original. Windows are in fair condition.
- Sealed window units (at the front entrance) are evidencing failure.

Damaged interior sill of sealed window

- Regular maintenance of windows includes replacement of failed weather stripping/sealant and damaged hardware. Window sills and tracks should be cleaned on a regular basis to ensure proper drainage. Repair as necessary.
- A few sealed windows (entrance) may require replacement sooner.

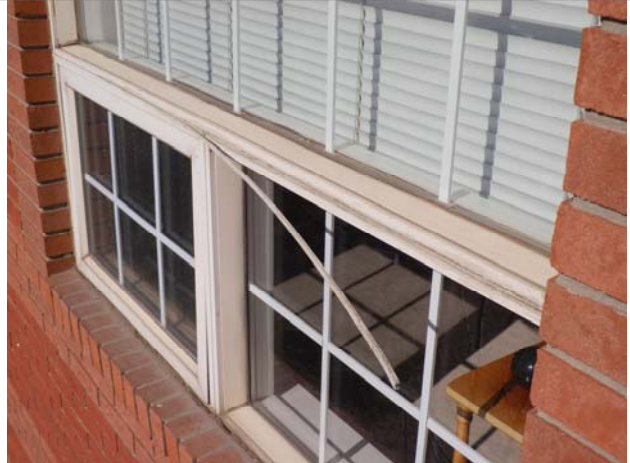
Damaged trim on window

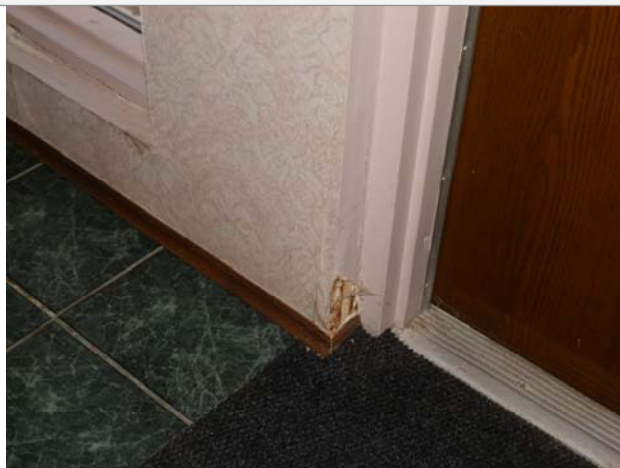
- Paint finishes in the hallways and stairwells are in fair condition. Some scuffing was noted. Some settlement cracking was noted.
- Some damage was noted inside the entrance.

Damaged wall finish at entrance

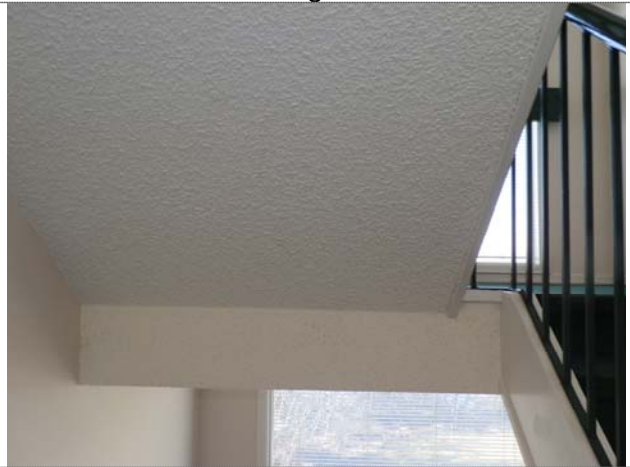
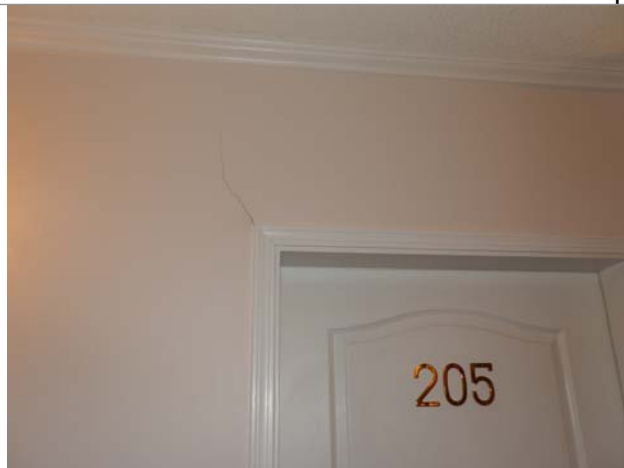
Cracking above unit door

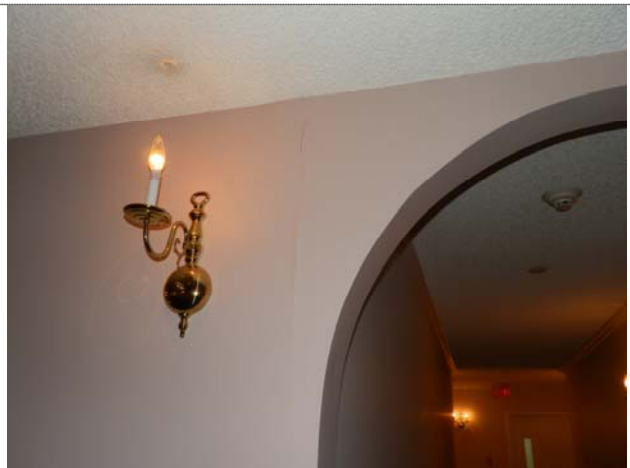
Cracking in wall finish

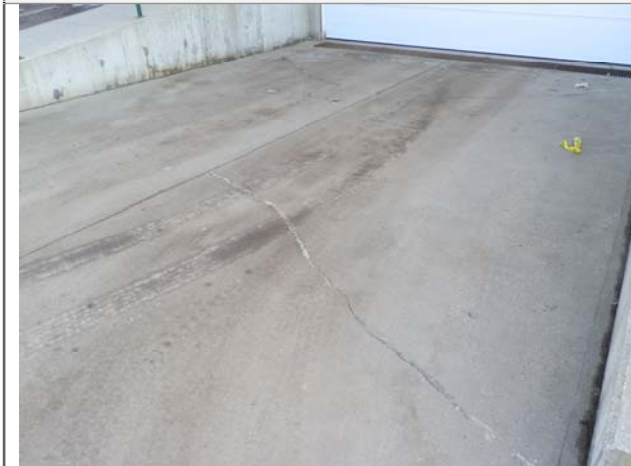
- The parkade ramp is poured concrete. The ramp is not heated. Some minor cracking and delamination is noted.
- Railings are in good condition.

Parkade ramp

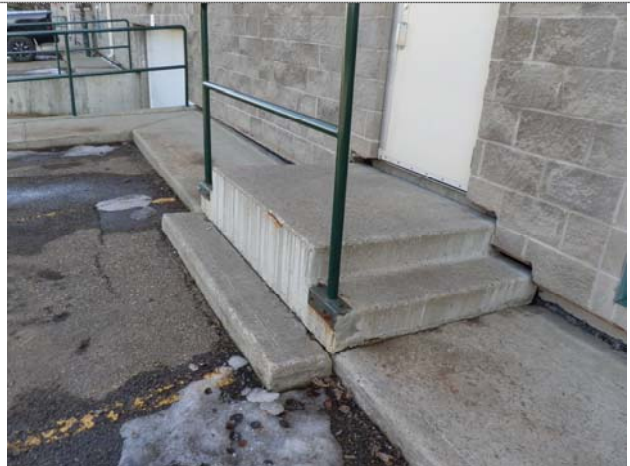
- Poured concrete walkways are installed on the north side of the building adjacent to the parkade ramp and parking. These concrete walkways are evidencing some spalling and deterioration.
- Railings adjacent to concrete are evidencing some rusting. Rust will accelerate concrete deterioration.

Concrete evidencing deterioration - railings rusting

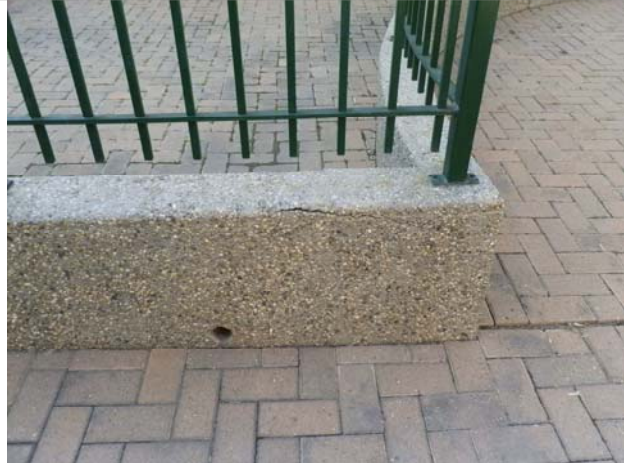
Concrete curb evidencing some minor deterioration

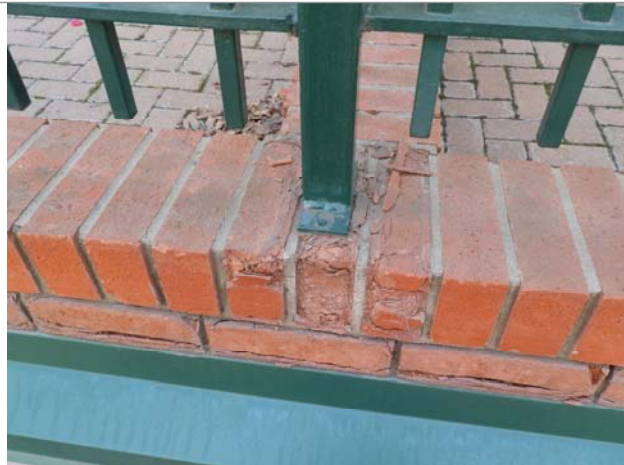
Damaged brick curbing

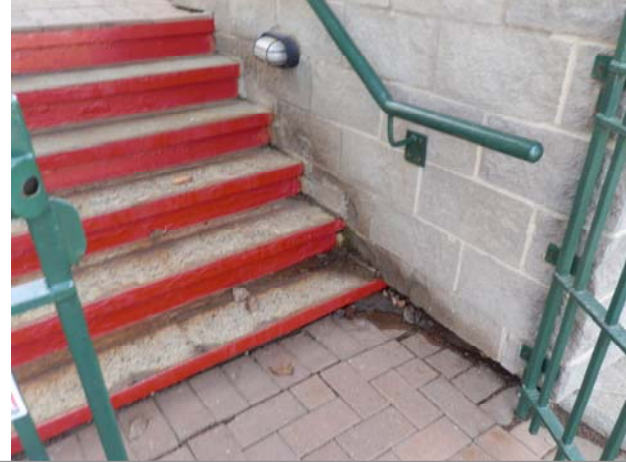
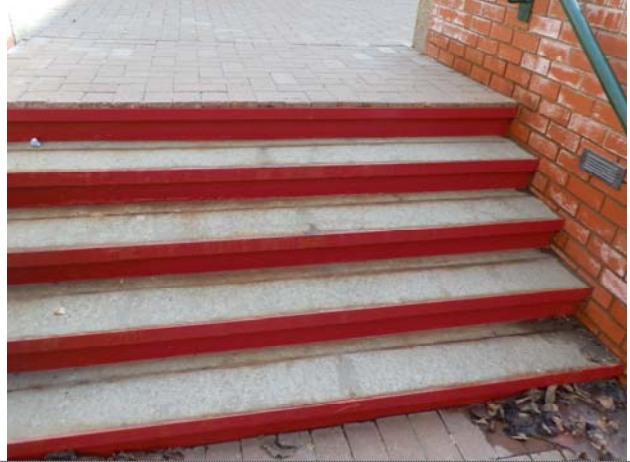
Concrete steps evidencing deterioration

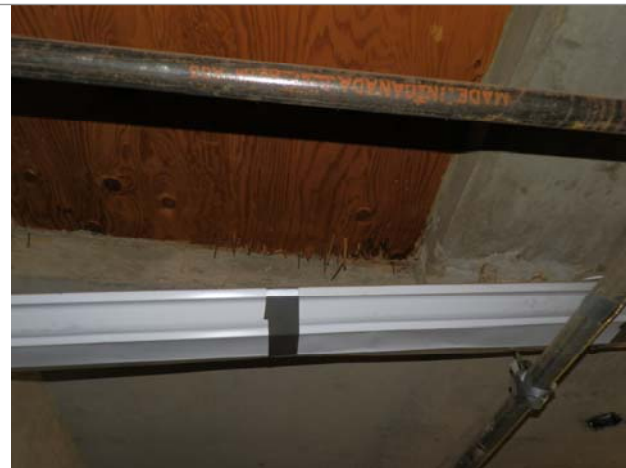
- The courtyard on the east and south side of the building is covered with brick unistone, rock and concrete. These concrete & brick components are in fair condition. The brick is uneven in several locations. The brick walls and curbs are evidencing some deterioration.
- The concrete steps are evidencing deterioration.
- The gazebo and other courtyard components are in good condition.
- A membrane has been installed between the ceiling of the parkade and the landscaping where it extends past the building. This membrane is not a life item and will require replacement. Although this membrane cannot be inspected, industry standard and experience suggest that it will last approximately 25 - 30 years. When it does fail the parkade roof will start to leak and cause concrete deterioration. One area of leaking is evident.

Leak in parkade ceiling

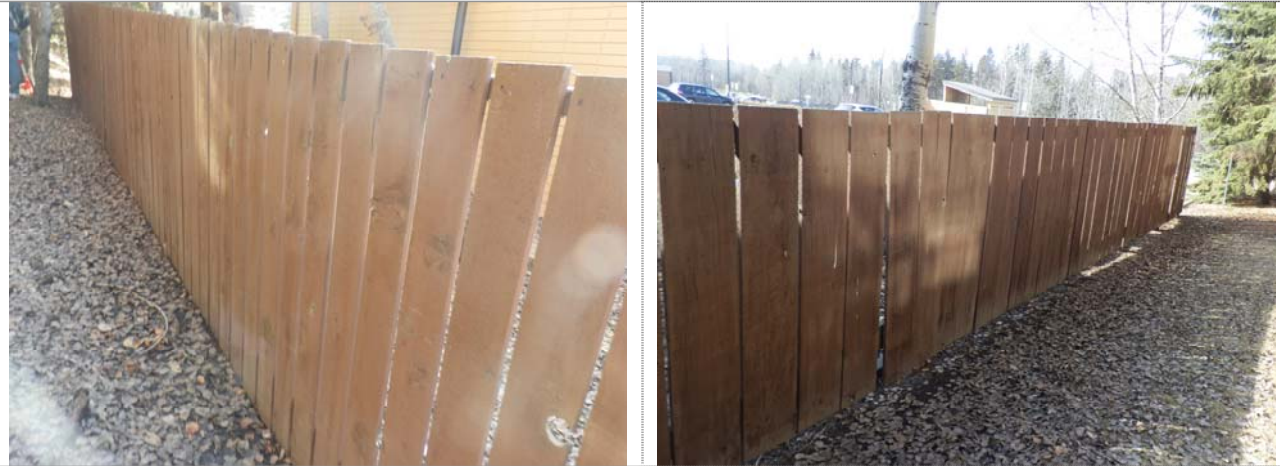
- Wood fencing is installed along the west side of the building.
- Fencing is original and evidencing some deterioration.

Wood fencing on west side of property
