RESERVE FUND STUDY
REPORT

[REDACTED]
CONDOMINIUM CORPORATION

CONDOMINIUM PLAN No. [REDACTED]

April 2017

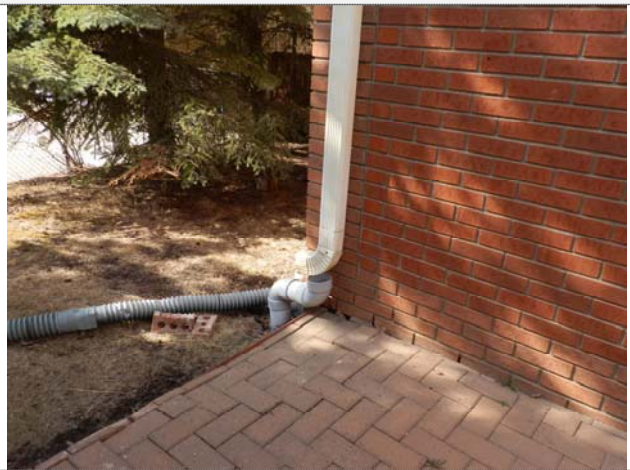
Downspout - bypassing drain - extension disconnected

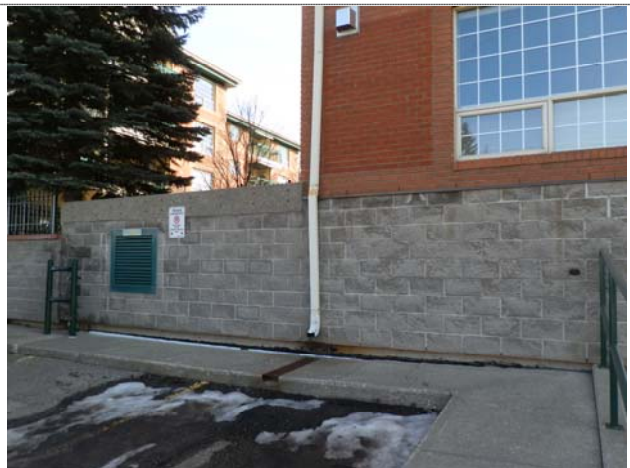
Downspout terminating onto walkway

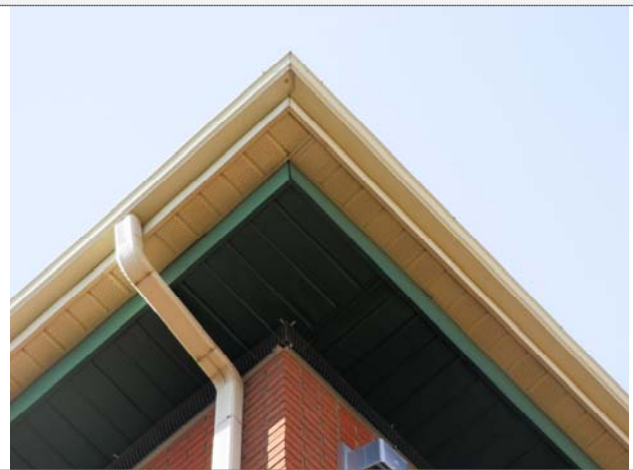
Soffit at roof overhang

- Fascia is prefinished metal and is installed at all roof terminations. Fascia is in good condition.
- Soffit is prefinished vented metal and is installed at all roof overhangs. Vented soffit allows air into the attic space. Soffit is in good condition.

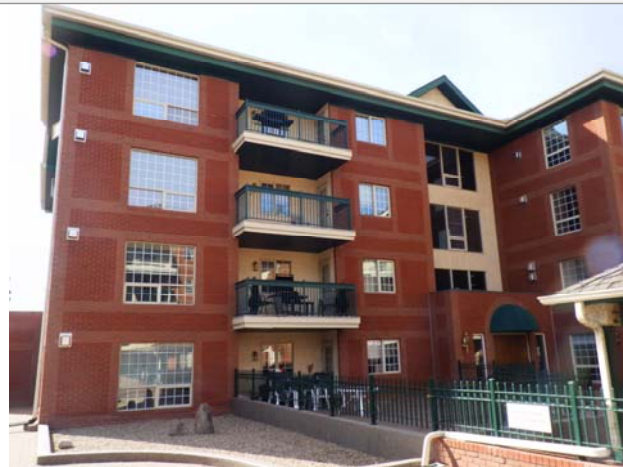
Front of building

- Building is clad with mostly brick. Stucco is installed at balconies and stairwells.
- Brick is in good condition and should last the life of the building with minimal maintenance and repair.
- There are a few areas where the mortar is damaged.
- Stucco is in good condition. It should last the life of the building. Minor repair and maintenance will be required.

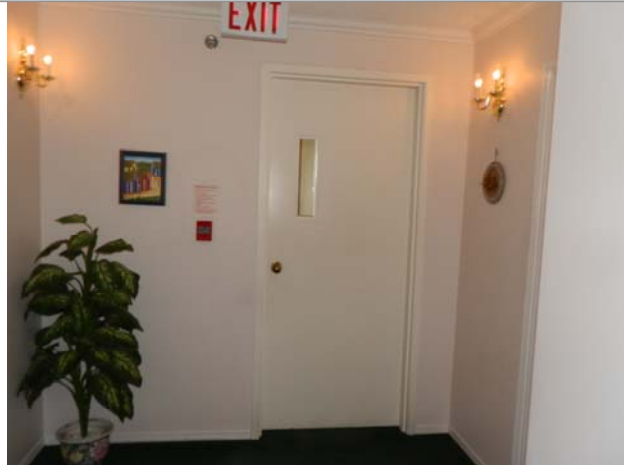
- Paint finishes in the hallways and stairwells are in fair condition. Some scuffing was noted. Some settlement cracking was noted.
- Some damage was noted inside the entrance.

Wall & door finish

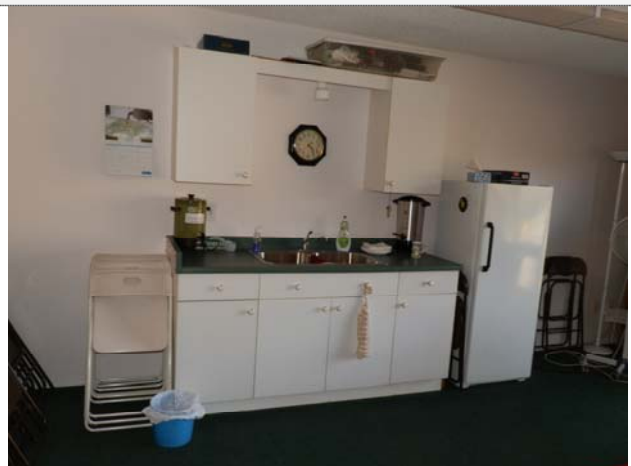
- Unit mailboxes are installed at the front entrance. Mailboxes are in good condition.
- Furniture, appliances and misc plumbing fixtures in the social room, guest suites and lobbies are in good condition.
- Guest suite furniture and finishes were recently upgraded and are in good condition. Access to the guest suite was not available at time of inspection.

Cabinetry and appliances in social room

- Repair damage to hinges and locks as they occur.
- Money is allocated every 10 years to repair/replace furniture, plumbing fixtures, and appliances as needed.

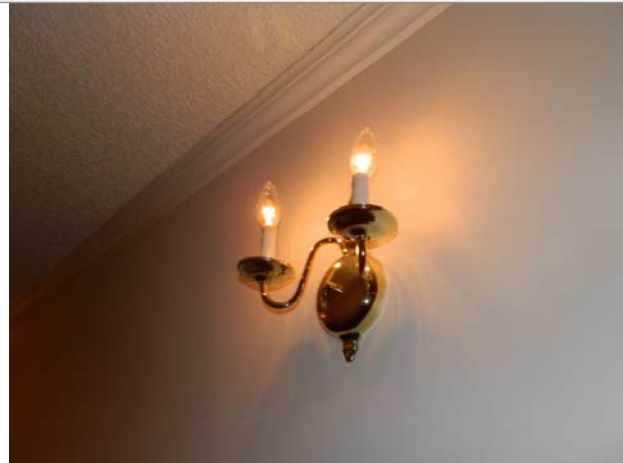
- All lighting is original and in fair condition.

Hallway incandescent lighting

- Replace lighting as needed.
- Full-scale replacement of all lighting should be scheduled within the next 6 - 11 years.

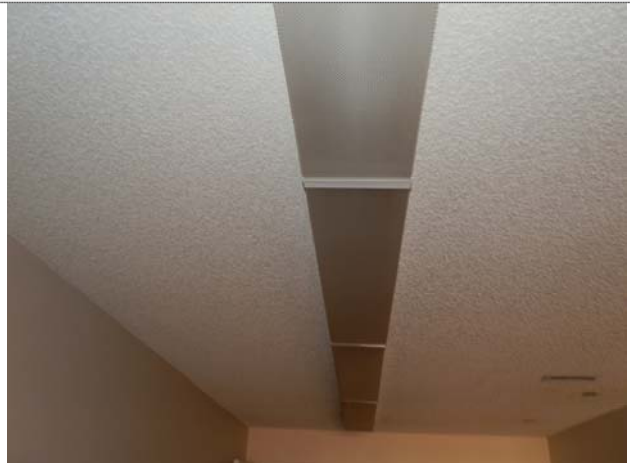
Social room florescent lighting

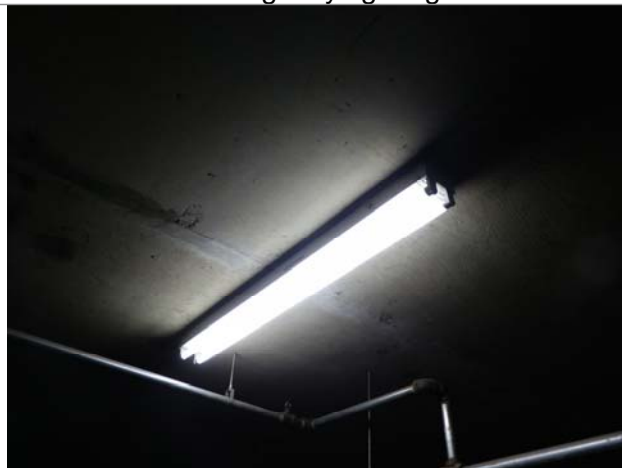
Parkade florescent lighting

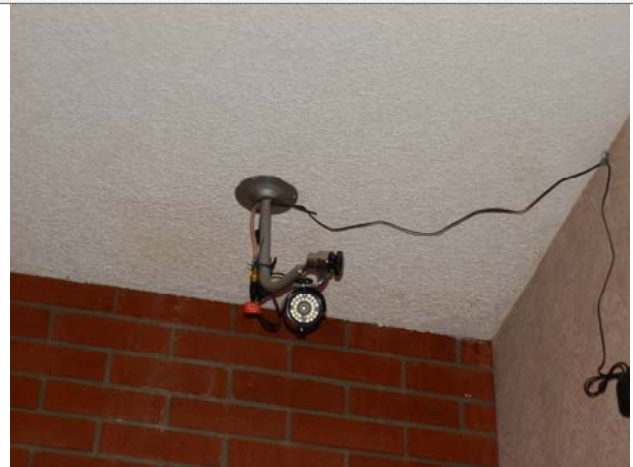
- Intercom system is original.
- System is located between entrance doors.
- CCTV camera is attached to system so unit owners can view visitors.

Camera attached to intercom system

- Repair as required.
- System should be scheduled for replacement within the next 6 years.

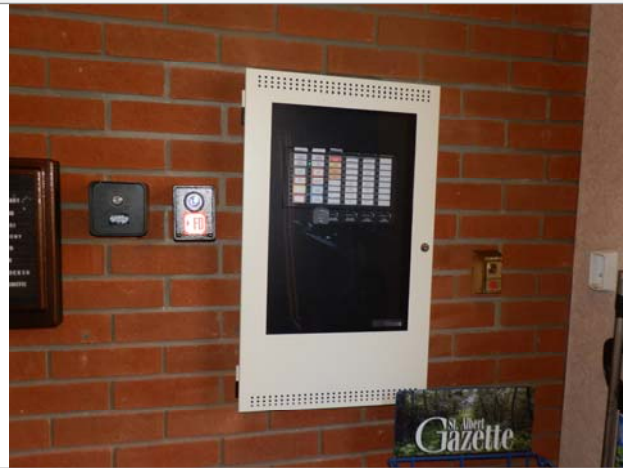
- Fire alarm system consists of Notifier panel at entrance, fire extinguishers, smoke detectors, pull stations, and alarms.
- Notifier panel was recently replaced.
- Fire alarm system components appear to be in good condition.

Notifier panel at entrance

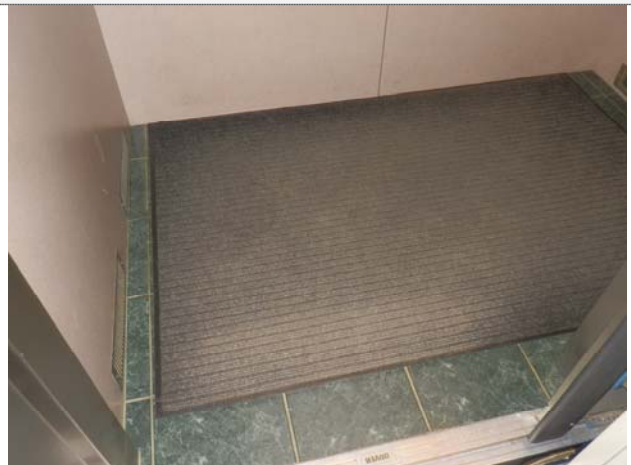
- One Dover hydraulic elevator services all 5 floors (4 residential and 1 parkade level). The elevator appears to be functioning properly.
- The interior cab finishes are in fair condition.

Interior elevator flooring finishes

– Money is allocated to complete major repairs every 15 years.

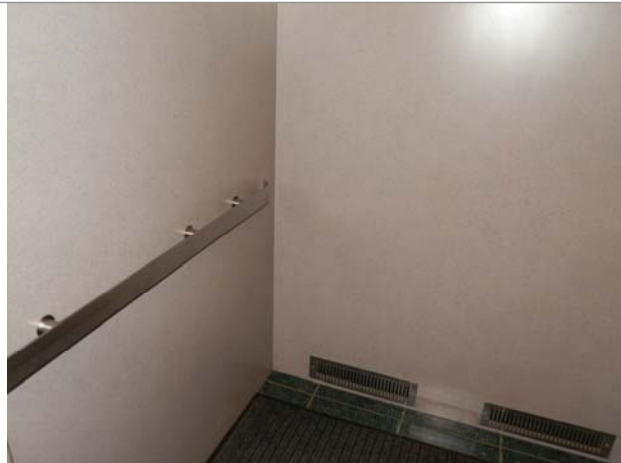
Interior elevator wall finishes

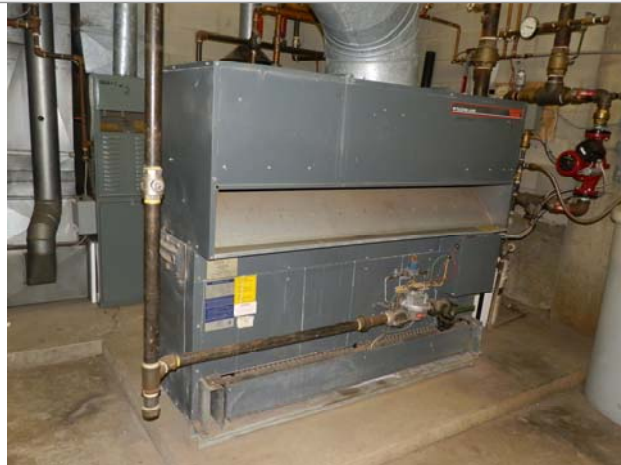
- Building is serviced by one Teledyne Laars boiler, two Grundfos heat pump, two hot water heaters/tanks, two expansion tanks, one system feeder and one recirc pump.
- All mechanical components are in fair condition.
- The State hot water heater has reached the end of its effective. These tanks/heaters generally last a maximum of 15 years.

Teledyne Laars boiler
M: HH 1200 IN 11K S: 1923996

- The State hot water heater should be scheduled for replacement this year.
- Regular maintenance and inspection is required.
- Money has been budgeted for the entire property to replace damaged sections of both the heat loop and domestic water piping as required. Complete replacement of both systems should not be required.

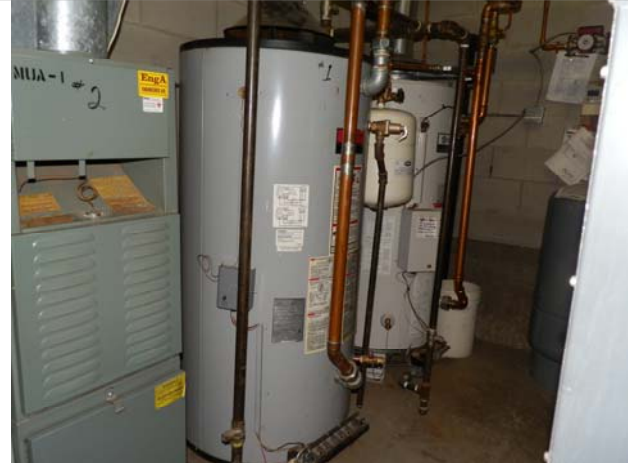
State hot water tank - 80 Gal
M: SBT 80 199 NE6 DFCGA S: 02000
A.O.Smith hot water tank - 76 Gal
M: BTRC199 118 S: 1337M002120

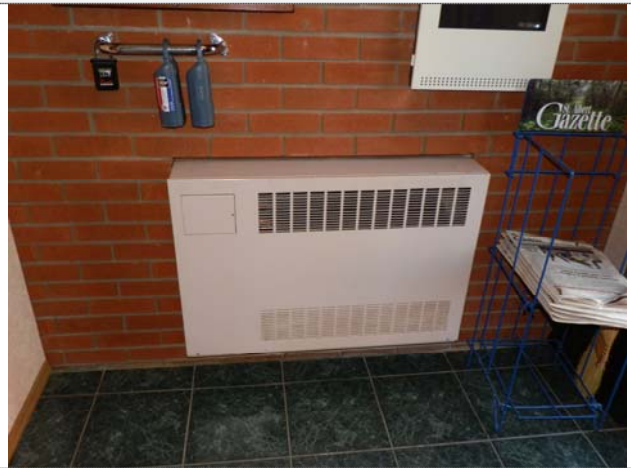
Cabinet heater at entrance

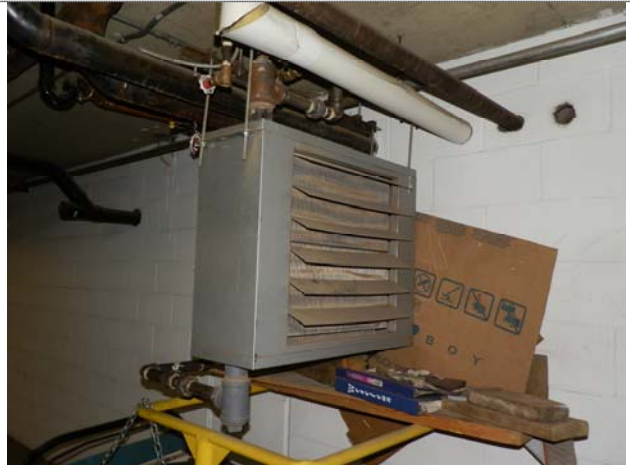
- Parkade makeup air system appears to be in good condition.
- One fan coil heater is installed in the parkade. Flammable materials should not be stored beside heater.
- QEL CO2 monitor in parkade appears to be in good condition.

Fan coil heater

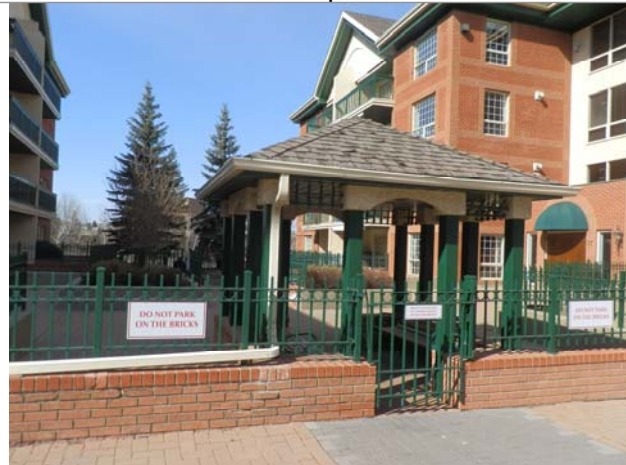
Gazebo entrance and wrought iron fencing

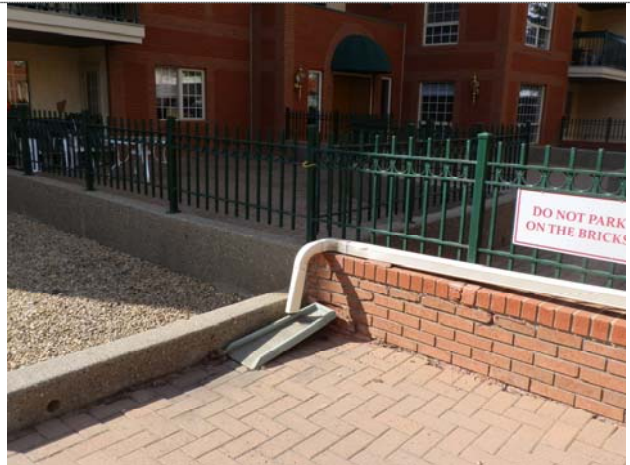
Brick and concrete walls/curbs with wrought iron fencing

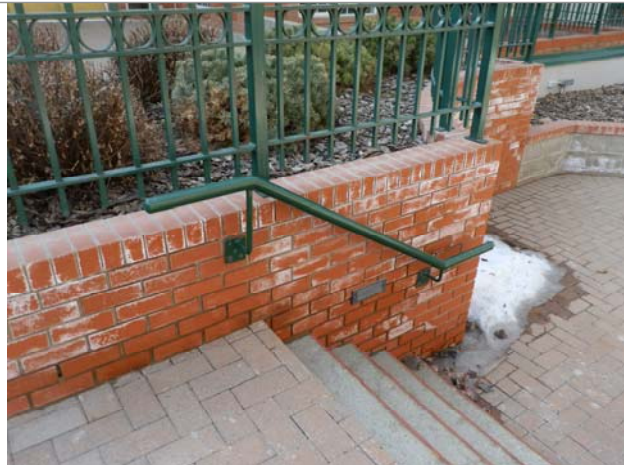
Brick walls with efflorescence

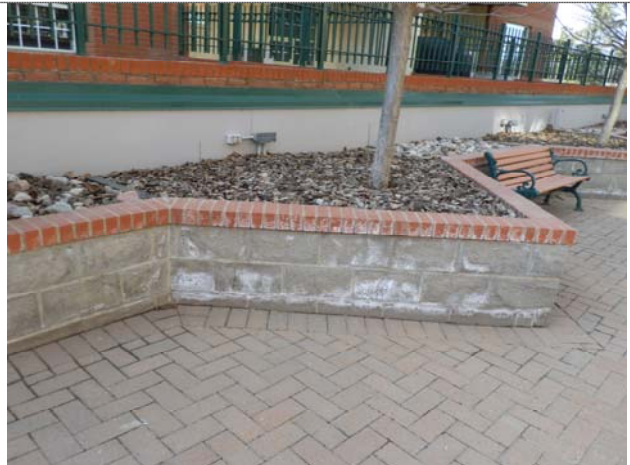
Block walls with efflorescence

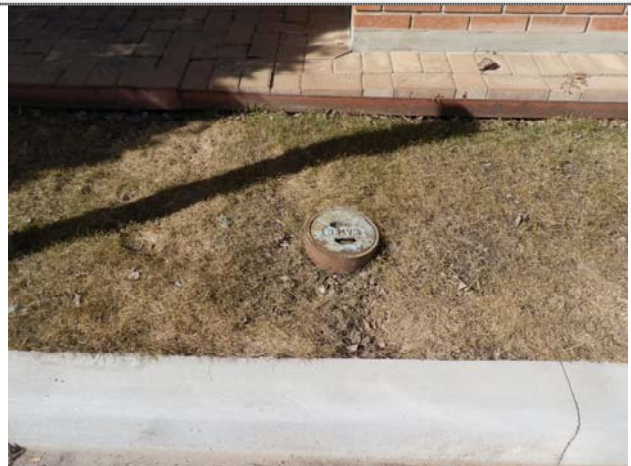
Shut off valve

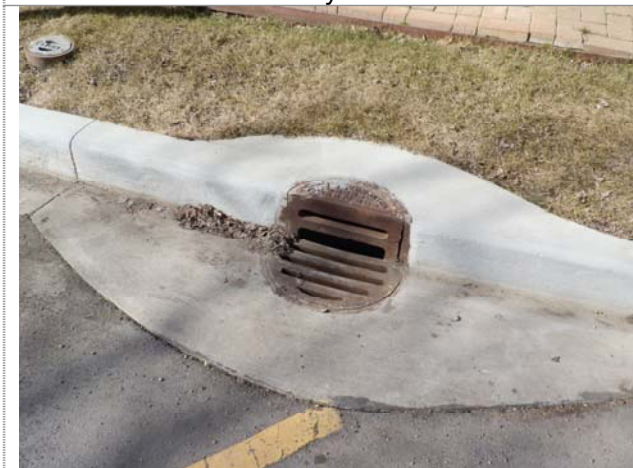
Drain in roadway

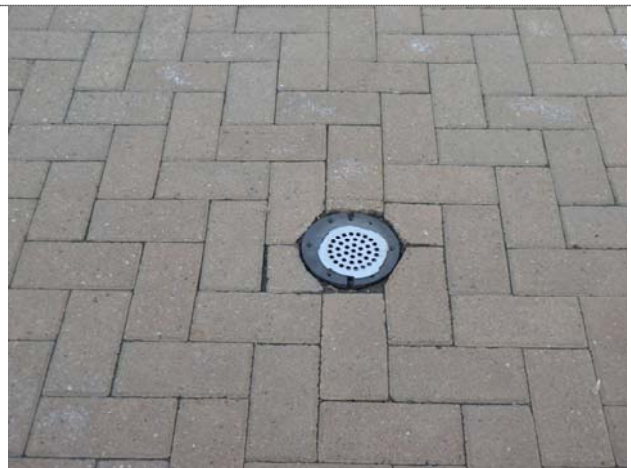
Drain in courtyard
