RESERVE FUND STUDY
REPORT

[REDACTED]
CONDOMINIUM CORPORATION

CONDOMINIUM PLAN No. [REDACTED]

April 2017

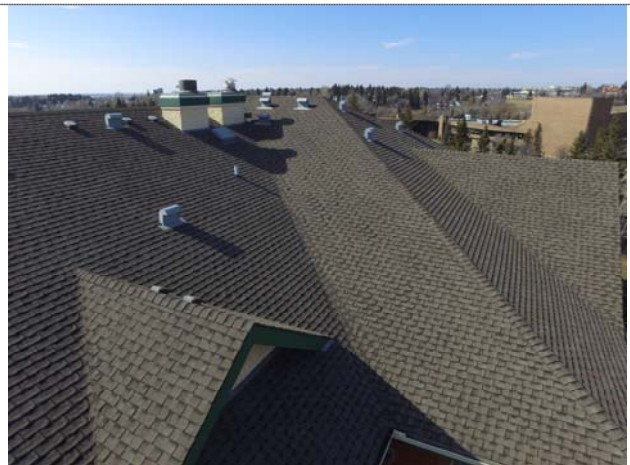
Shingle deterioration evident

- 1.0 Shingle roofing is original and evidencing deterioration. Shingles should be replaced within the next 3 years. Lower flat roof should be replaced at the same time. Page 10

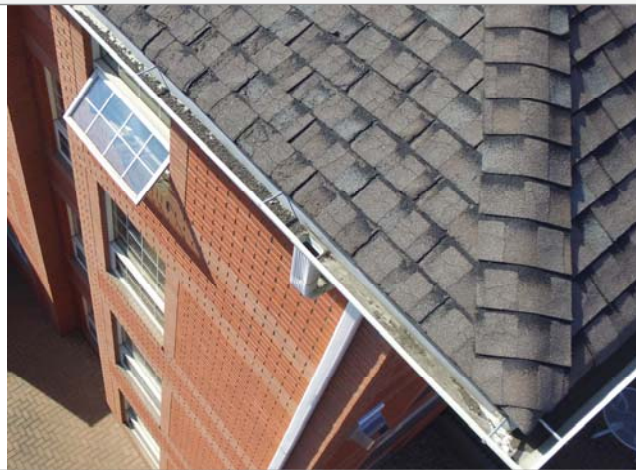
- Eavestroughs are securely fastened to fascia with ferrules (nails).
- Eavestroughs appear to have minor organic debris. This debris may cause downspouts to plug and back up.
- Downspouts terminate onto landscaping. Internal drainage system is no longer being used. A few downspouts terminate close to the foundation walls.

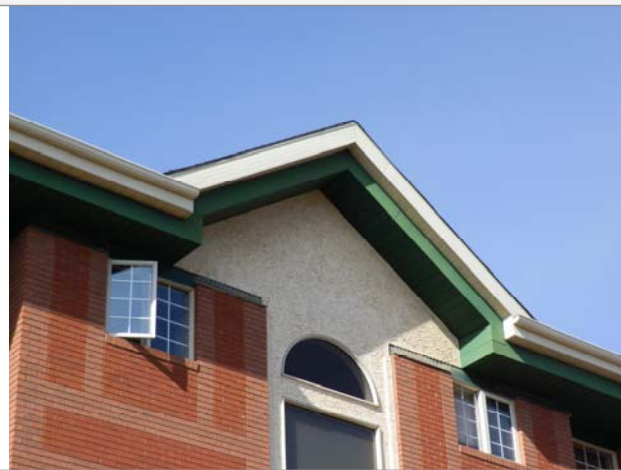
Fascia at roof termination

- Fascia is prefinished metal and is installed at all roof terminations. Fascia is in good condition.
- Soffit is prefinished vented metal and is installed at all roof overhangs. Vented soffit allows air into the attic space. Soffit is in good condition.

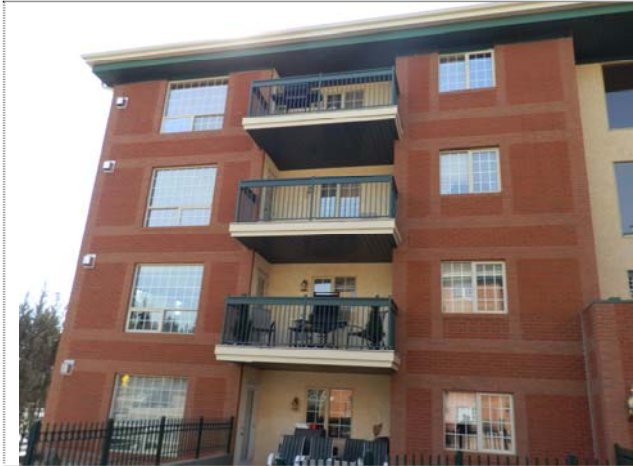
Unit windows

- Windows are original. Windows are in fair condition.
- Sealed window units (at the front entrance) are evidencing failure.

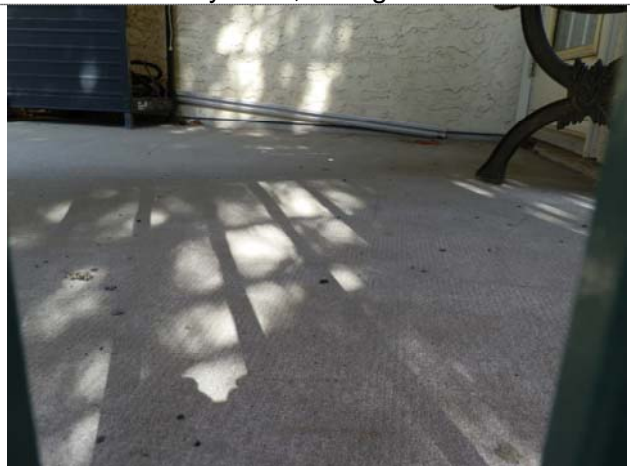
Balcony membrane

- Balconies are covered with a PVC membrane. This membrane is nearing the end of its effective life - balconies inspected did not evidence any obvious deterioration.
- Railings are wood. Metal capping was recently added to the railings. Railings are in good condition.
- Balcony fascia and soffit are also in good condition. No deficiencies were noted.

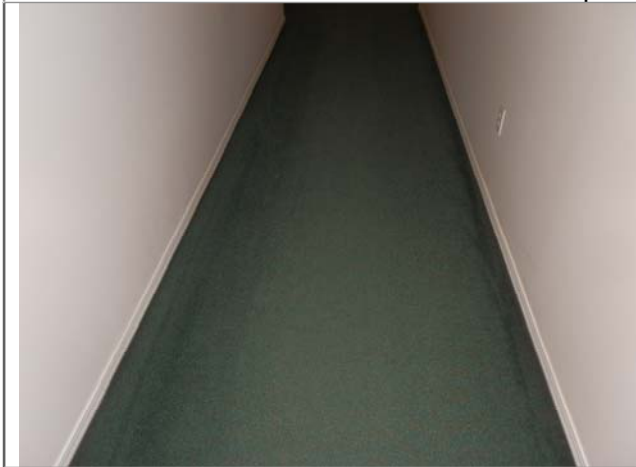
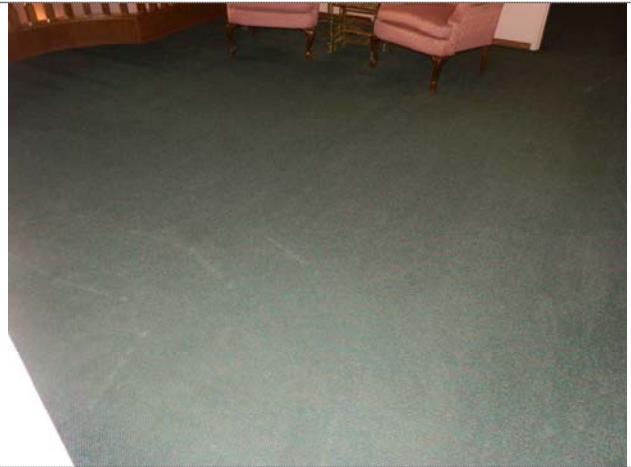
Hallway carpet

- Hallway and stairwell carpet is original, however they are in fair condition with minor wear.
- Tile in parkade elevator lobby was recently replaced and is in good condition. Tile in the main entrance lobby is also in good condition.
- Linoleum in garbage chute rooms is in good condition.

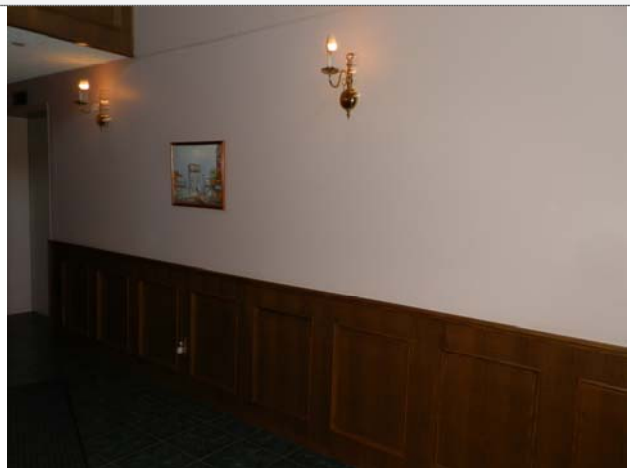
- 9.0 Interior wall finishes are evidencing some cracking and wear. It is recommended that hallway and stairwell walls and doors be painted within the next 2 years. This includes wall paper as well. Page 24

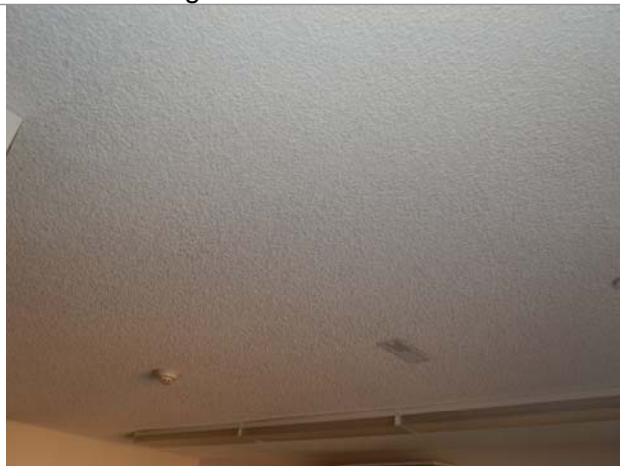
- Paint finishes in the hallways and stairwells are in fair condition. Some scuffing was noted. Some settlement cracking was noted.
- Some damage was noted inside the entrance.

Ceiling finish

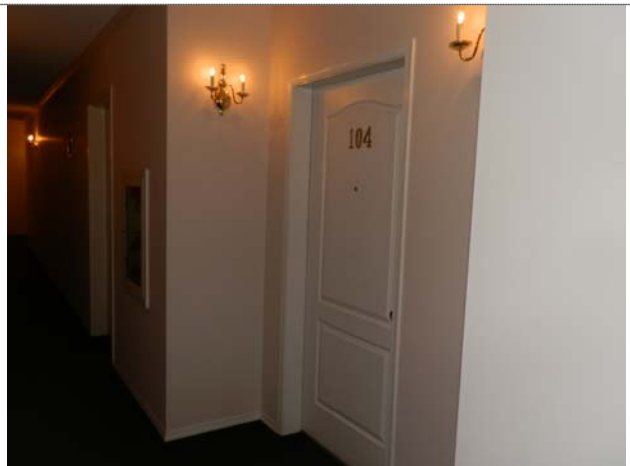
Wall and door finish

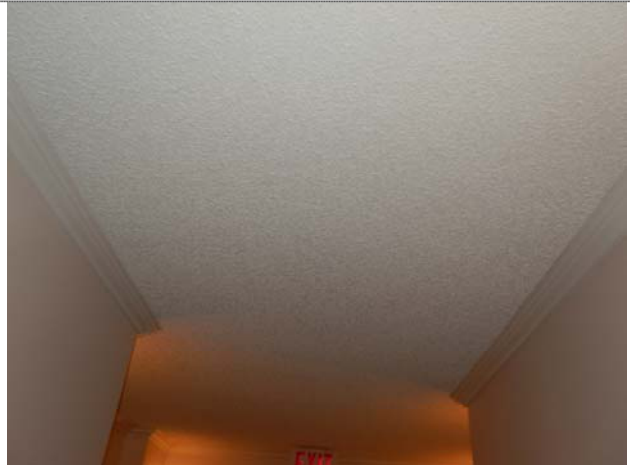
Ceiling finish

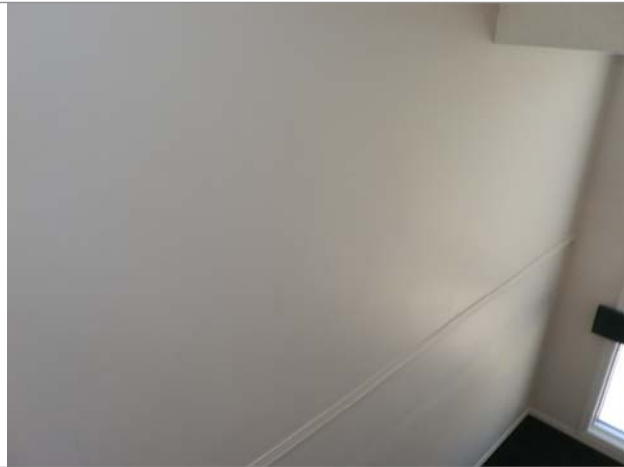
Stairwell paint finishes

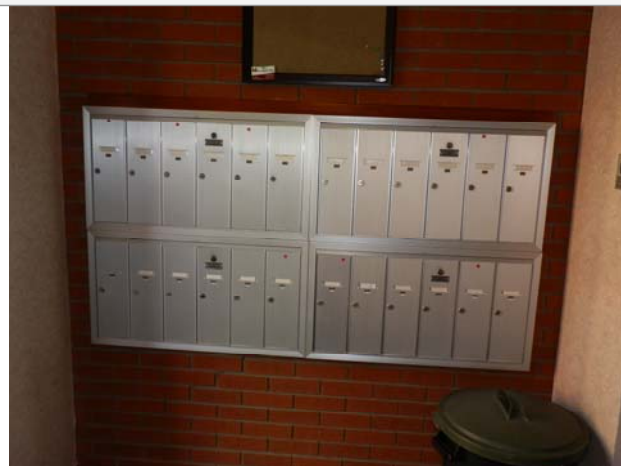
- Unit mailboxes are installed at the front entrance. Mailboxes are in good condition.
- Furniture, appliances and misc plumbing fixtures in the social room, guest suites and lobbies are in good condition.
- Guest suite furniture and finishes were recently upgraded and are in good condition. Access to the guest suite was not available at time of inspection.

Unit mailbox

- Repair damage to hinges and locks as they occur.
- Money is allocated every 10 years to repair/replace furniture, plumbing fixtures, and appliances as needed.

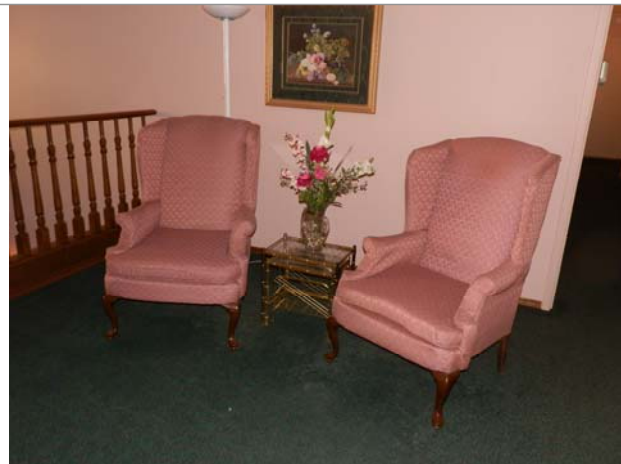
Furniture in 2nd floor lobby

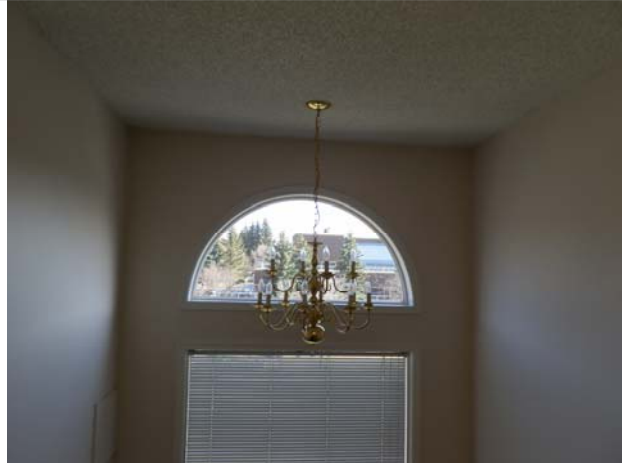
- All lighting is original and in fair condition.

Stairwell chandelier

- Replace lighting as needed.
- Full-scale replacement of all lighting should be scheduled within the next 6 - 11 years.

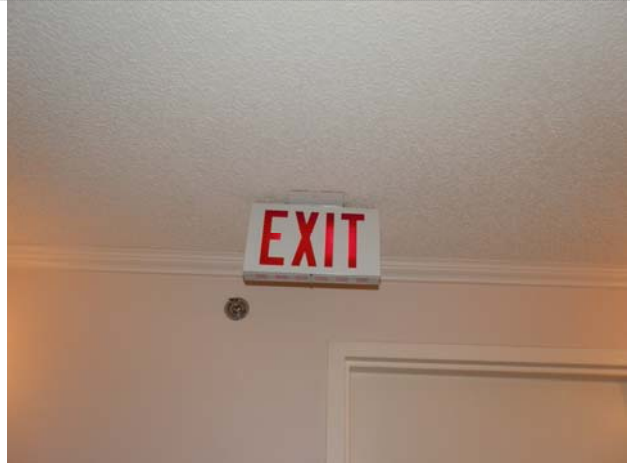
Exit signage

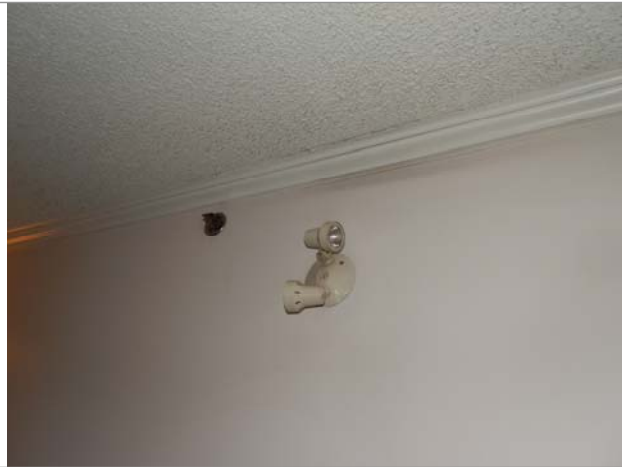
Emergency lighting

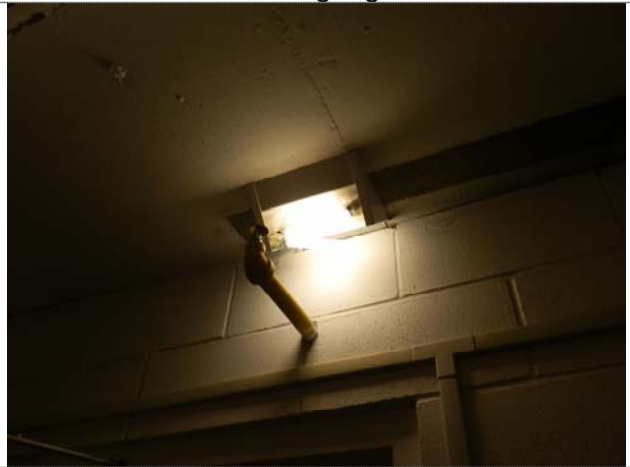
Parkade lighting

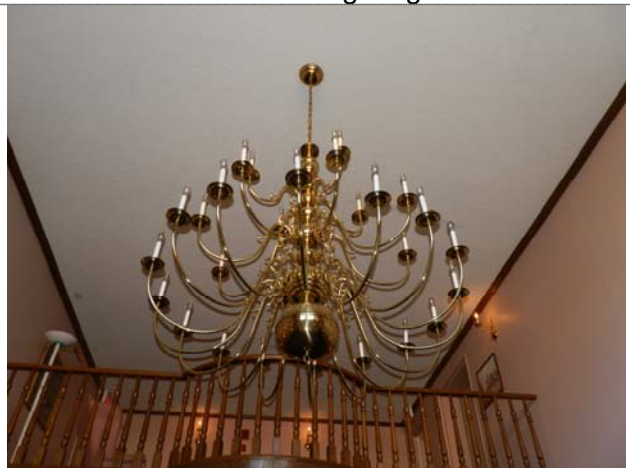
Main entrance chandelier

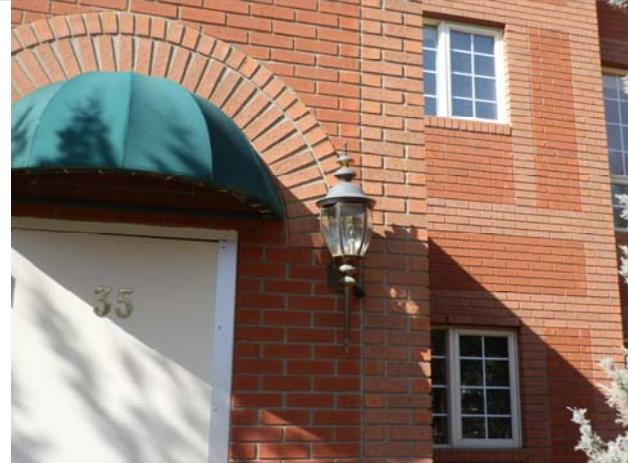
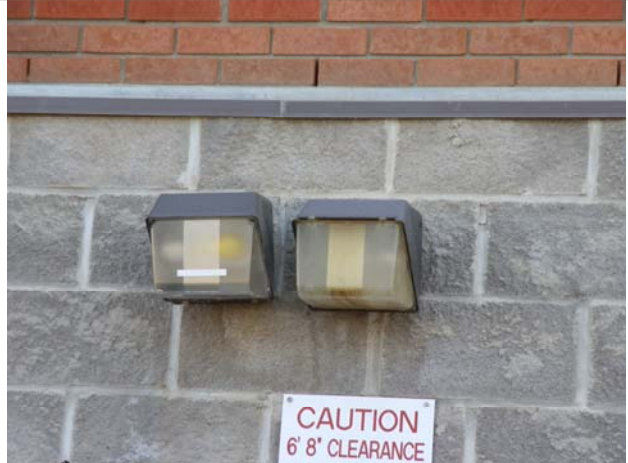
Building exterior lighting

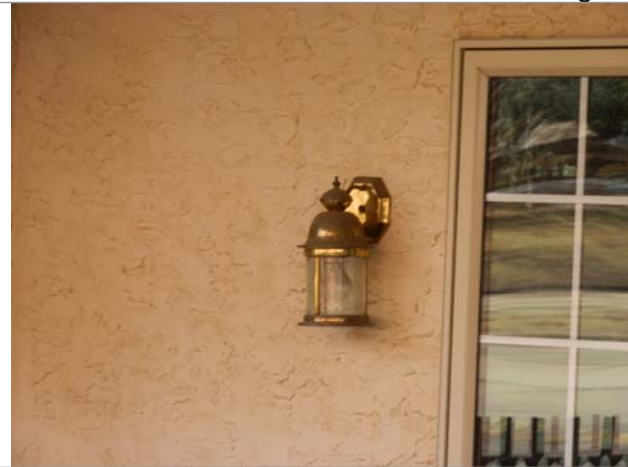
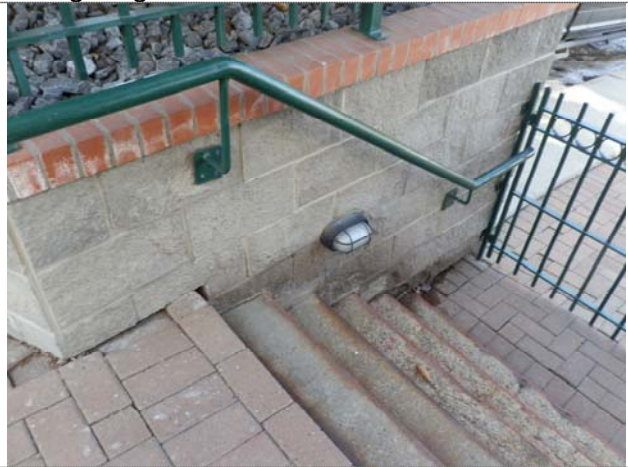
Unit exterior lighting

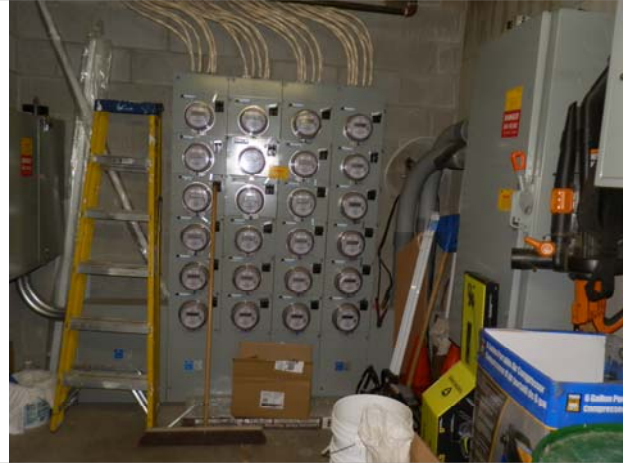
- Electrical distribution for the building is in good condition.
- No anomalies were noted.

Unit meters

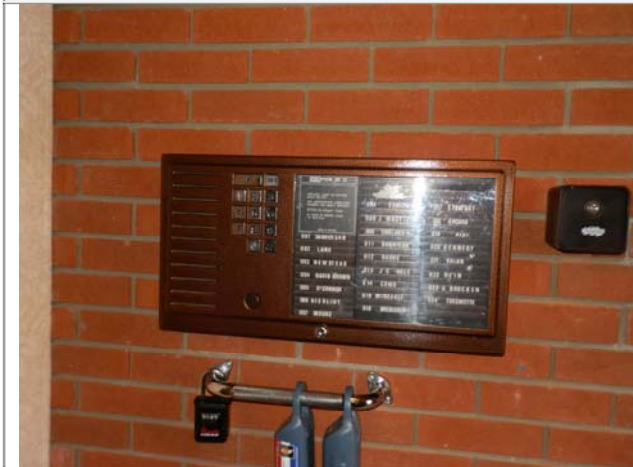
- Intercom system is original.
- System is located between entrance doors.
- CCTV camera is attached to system so unit owners can view visitors.

Intercom panel

- Repair as required.
- System should be scheduled for replacement within the next 6 years.

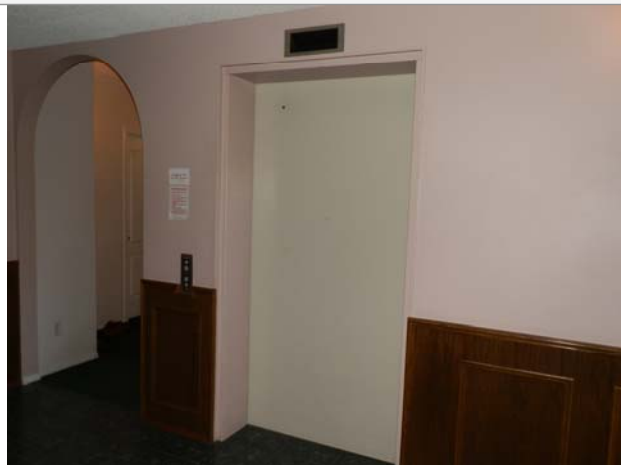
- One Dover hydraulic elevator services all 5 floors (4 residential and 1 parkade level). The elevator appears to be functioning properly.
- The interior cab finishes are in fair condition.

Elevator

– Money is allocated to complete major repairs every 15 years.

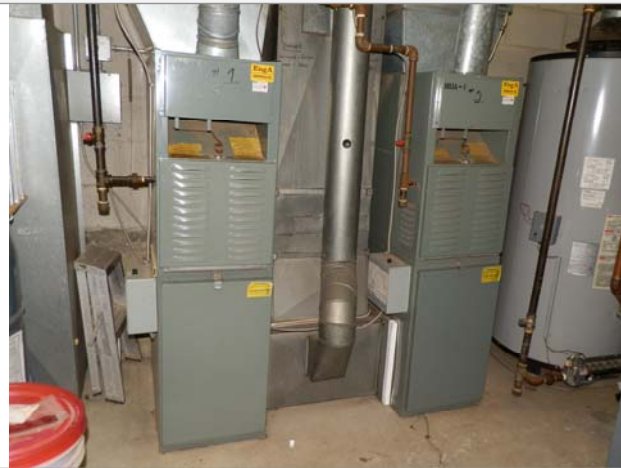
- The makeup air system consists of two Eng A furnaces. Furnaces are in good condition.
- There are a few cabinet heaters located in the stairwells and at the entrances. Heaters are in good condition.

Eng A furnaces

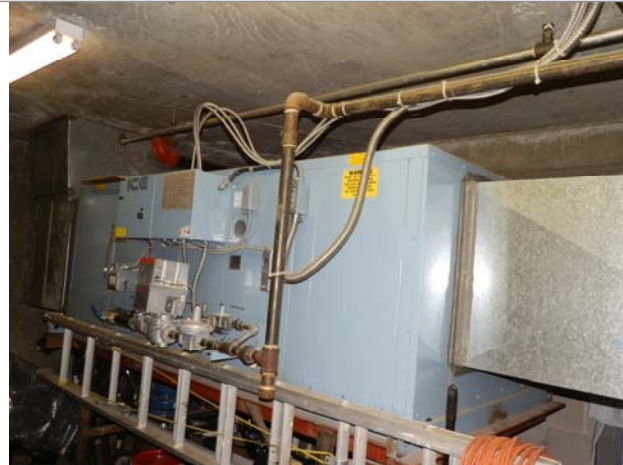
- Parkade makeup air system appears to be in good condition.
- One fan coil heater is installed in the parkade. Flammable materials should not be stored beside heater.
- QEL CO2 monitor in parkade appears to be in good condition.

Parkade makeup air unit
M: BMA90 S: 1092025

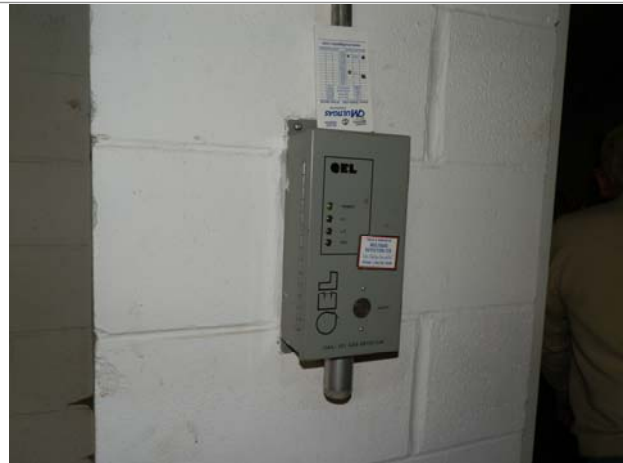
QEL CO2 monitor in parkade

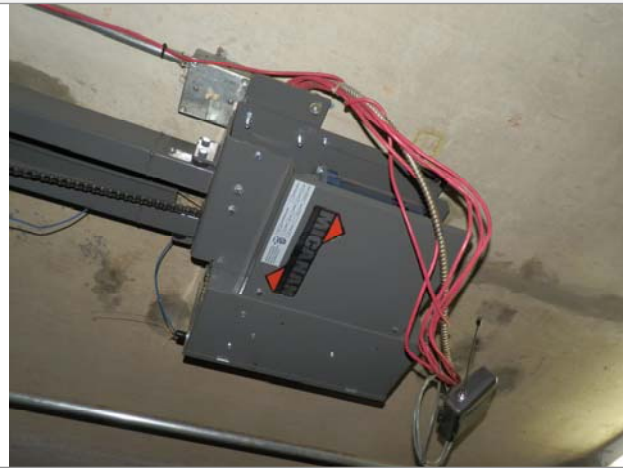
- Parkade overhead door appears to be in fair condition.
- Parkade motor to operate the door appears to be functioning well.

Micanan motor & door controls

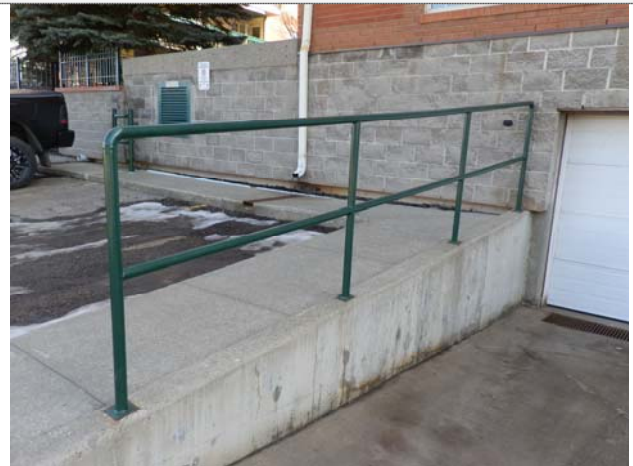
- The parkade ramp is poured concrete. The ramp is not heated. Some minor cracking and delamination is noted.
- Railings are in good condition.

Railings

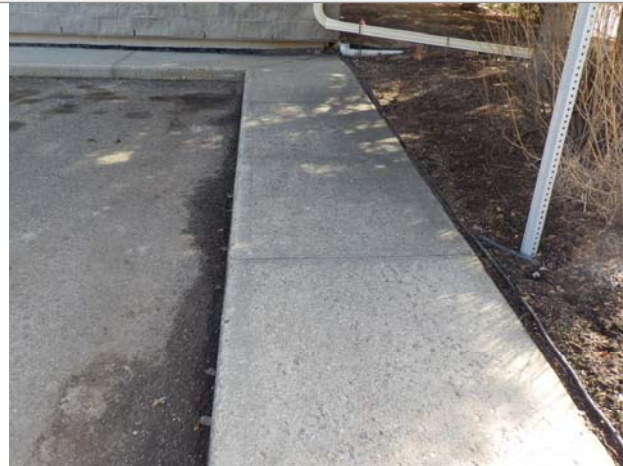
- Poured concrete walkways are installed on the north side of the building adjacent to the parkade ramp and parking. These concrete walkways are evidencing some spalling and deterioration.
- Railings adjacent to concrete are evidencing some rusting. Rust will accelerate concrete deterioration.

Concrete walkway

- Paint railings occasionally to prevent further concrete deterioration. This is an operating expense.

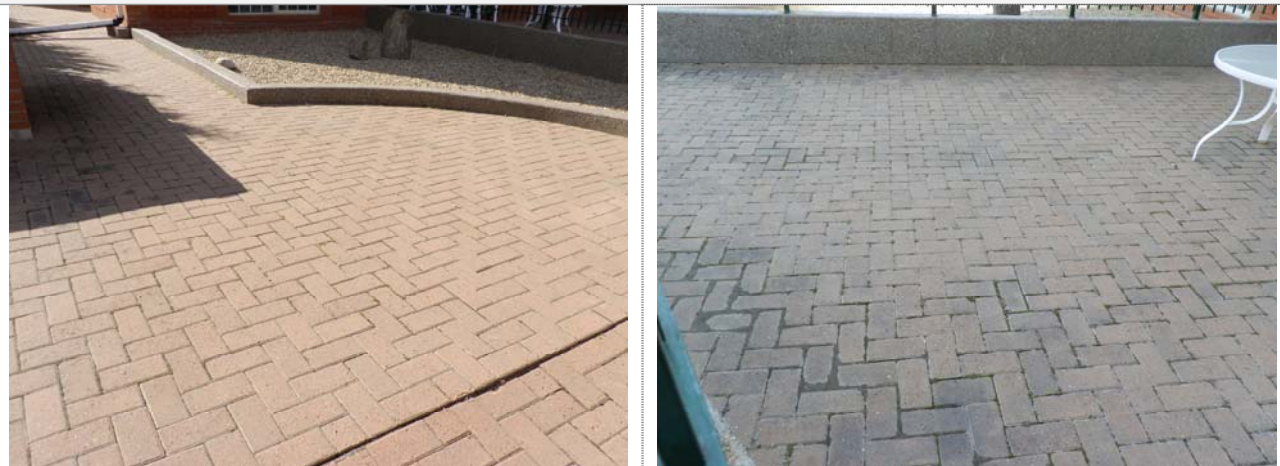
- The courtyard on the east and south side of the building is covered with brick unistone, rock and concrete. These concrete & brick components are in fair condition. The brick is uneven in several locations. The brick walls and curbs are evidencing some deterioration.
- The concrete steps are evidencing deterioration.
- The gazebo and other courtyard components are in good condition.
- A membrane has been installed between the ceiling of the parkade and the landscaping where it extends past the building. This membrane is not a life item and will require replacement. Although this membrane cannot be inspected, industry standard and experience suggest that it will last approximately 25 - 30 years. When it does fail the parkade roof will start to leak and cause concrete deterioration. One area of leaking is evident.

Brick unistone in courtyard - parkade below

- Money is allocated to replace the parkade membrane in two phases. Attempting to replace the membrane in smaller sections would be difficult as determining exact failure locations is impossible as water follows the path of least resistance. Unfortunately brick unistone will require replacement in conjunction with membrane replacement.

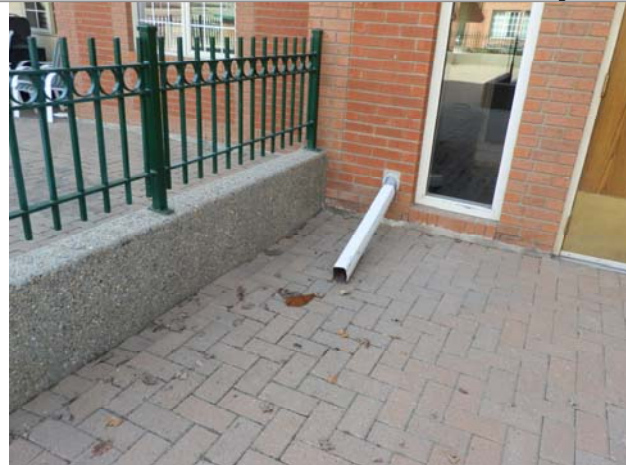
Brick unistone, concrete curb & wrought iron fence

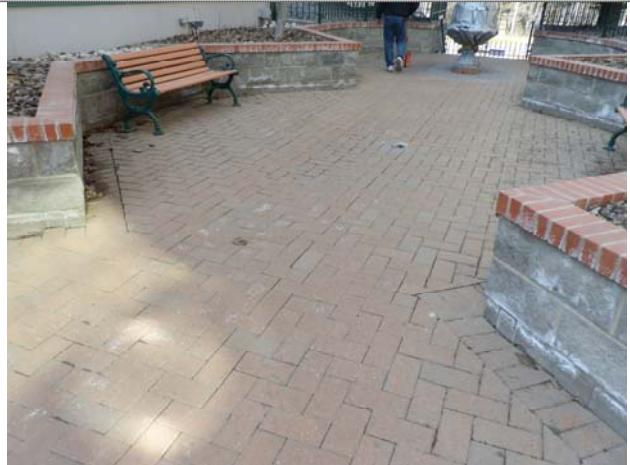
Brick unistone - no parkade below

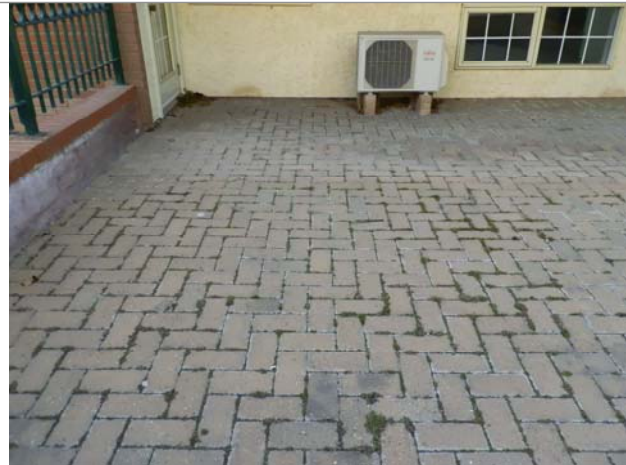
Brick unistone - parkade below

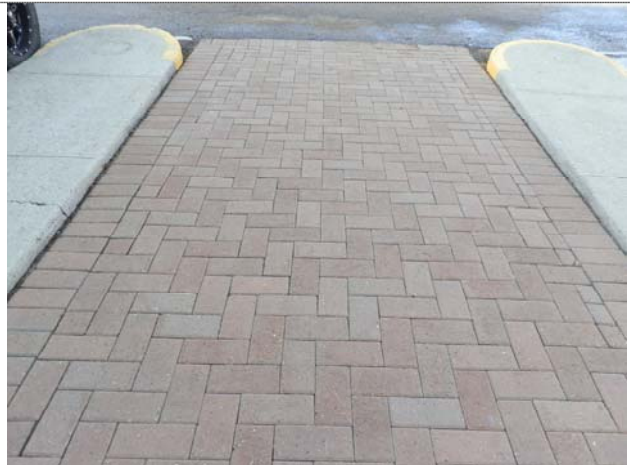
Brick unistone

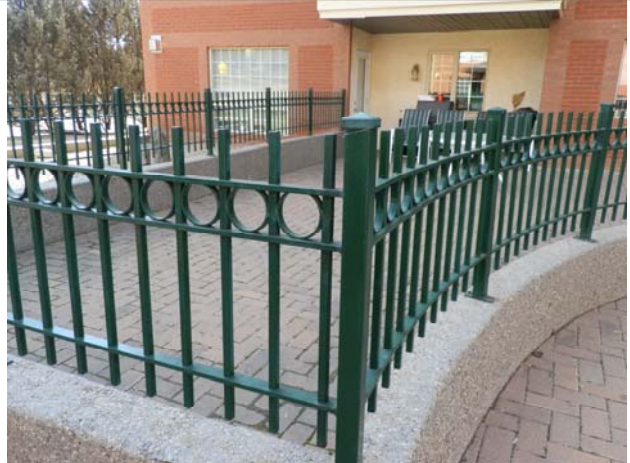
Wrought iron fencing

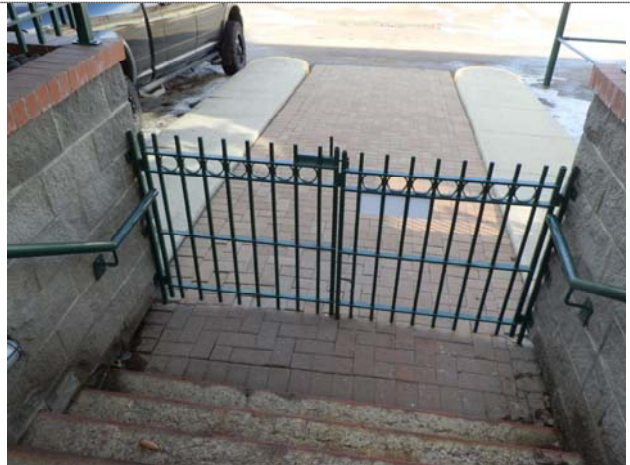
Wrought iron fencing

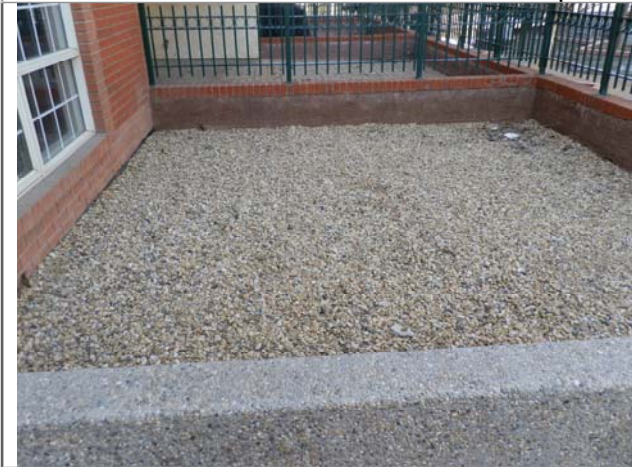
Parkade membrane below rocks

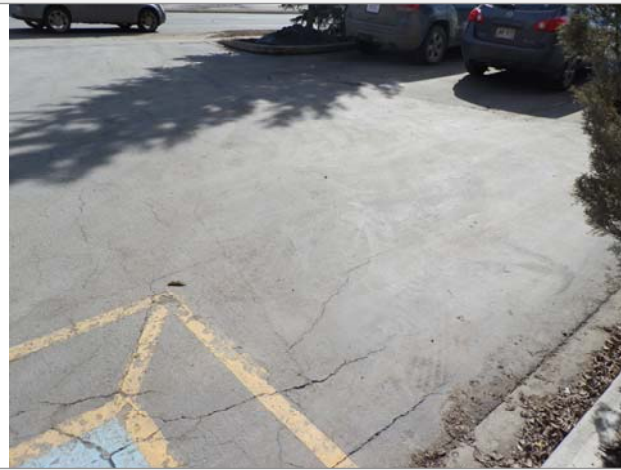
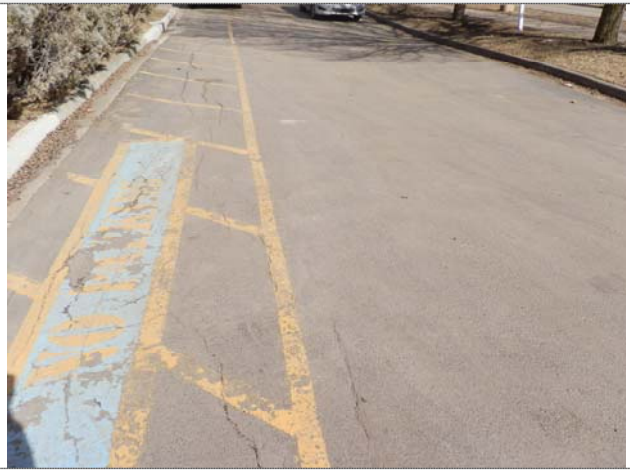
- The asphalt roadway at the front of the property adjacent to city street has been recently resurfaced and is in good condition. Some minor cracking was noted.
- The asphalt parking on the north side of the building adjacent to the parkade ramp is nearing the end of its effective life.

Asphalt surface at front of building

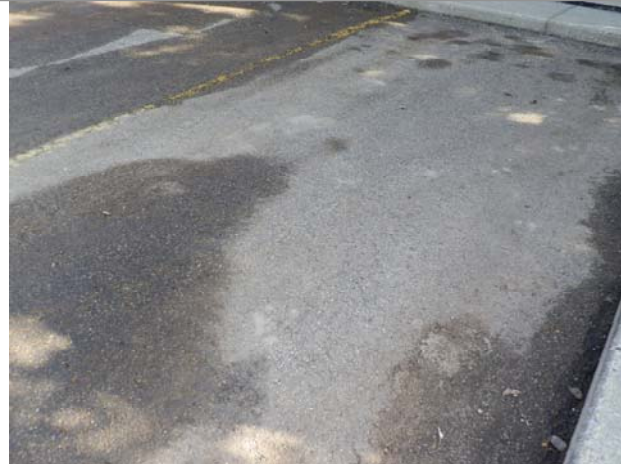
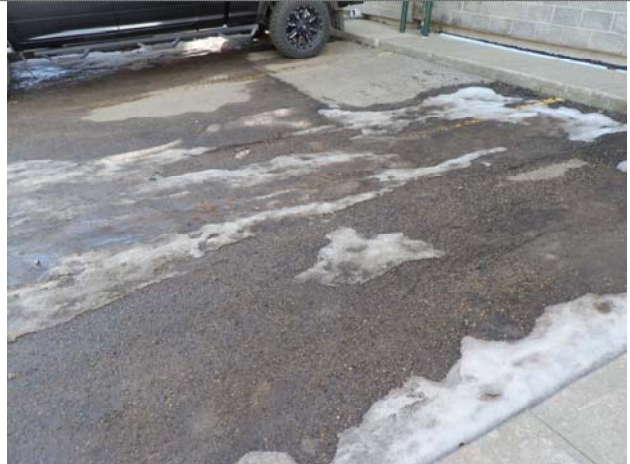
Asphalt surface adjacent to parkade ramp

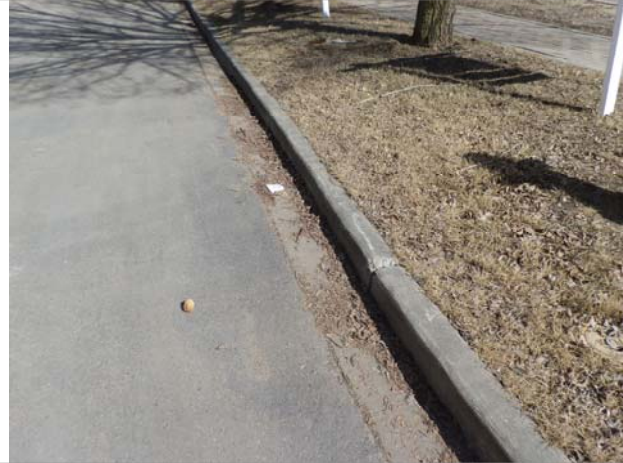
- Poured curbs are installed around the asphalt.
- Curbs are in good condition.

Poured curbing

- Repair in conjunction with walkway replacement if needed.

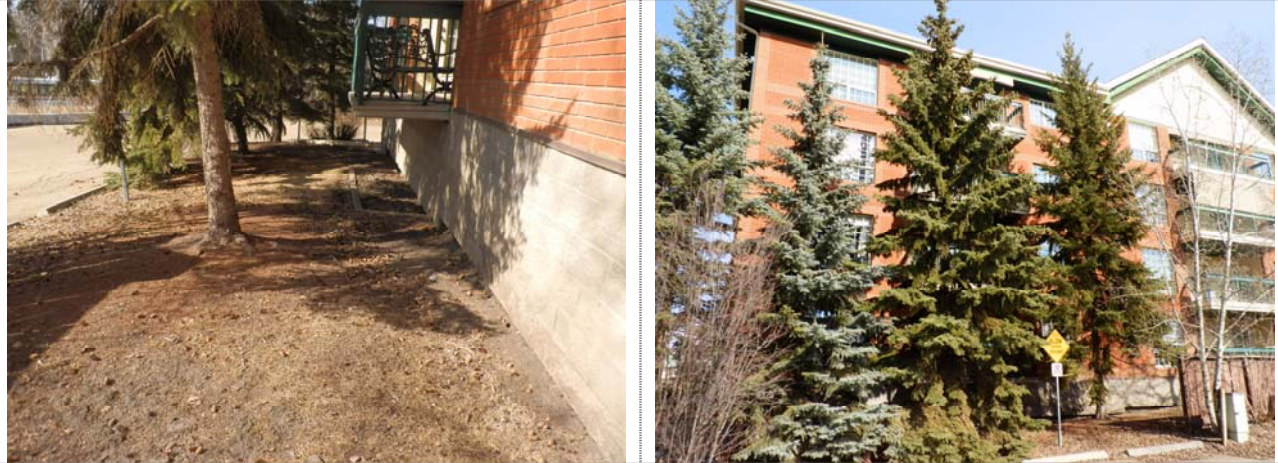
- Large trees grow in close proximity of the building.
- Landscaping is bare around the west perimeter of the building.

Landscaping

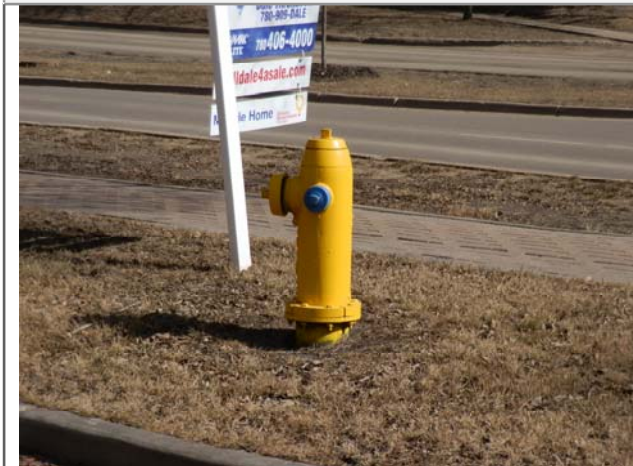
Fire hydrant

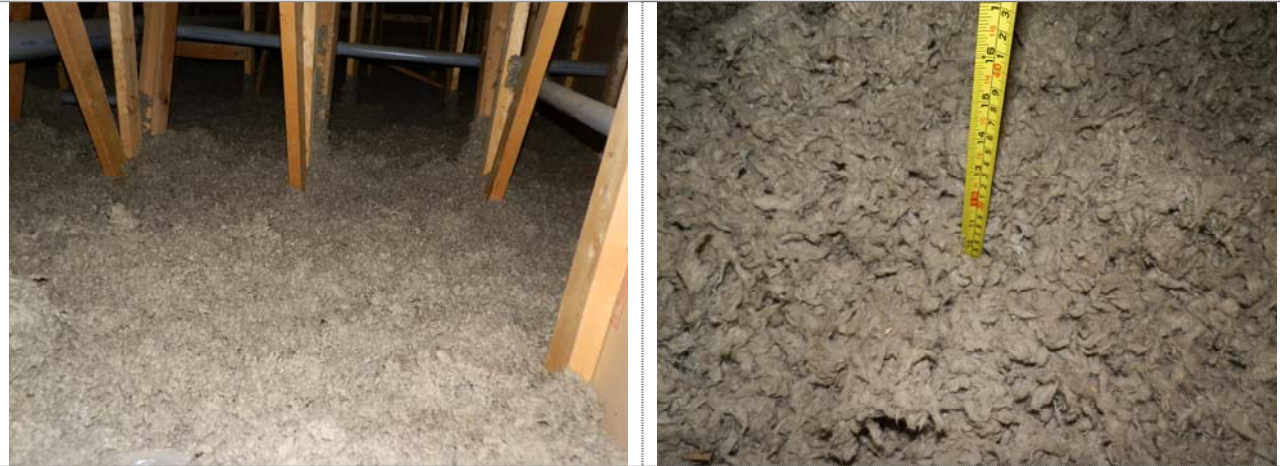
- Attic insulation consists of approximately 11" of blown in cellulose. Soffits are clear and attic has sufficient air movement.

Attic space
